UTAH STATE CAPITOL ARCHITECTURE: EXTERIOR SURVEY REPORT

ELEVATION LOCATION: UPPER DRUM

Survey Date: 4/26/00

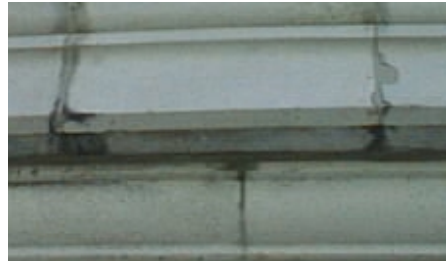
Location: West Elevation balustrade rail

Description: Balustrade

Condition: J, CK

Mortar joint damage, covered poorly with caulking

Comments: cracking, separated from stone, appears to be made of concrete. Calk is very thick, gooped on. Rail also B L/N 7.

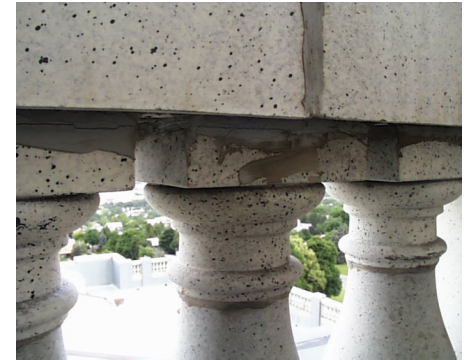
Location: East Elevation

Description: Balustrade

Condition: J

Mortar joint with missing or loose mortar

Comments: Joints cracking/ weathered esp. underside under drip edge.

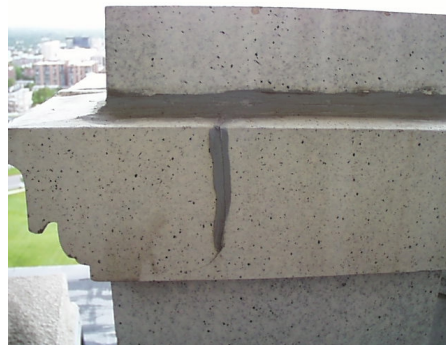
Location: East Elevation

Description: Balustrade

Condition: BR

Broken, severely cracked or chipped

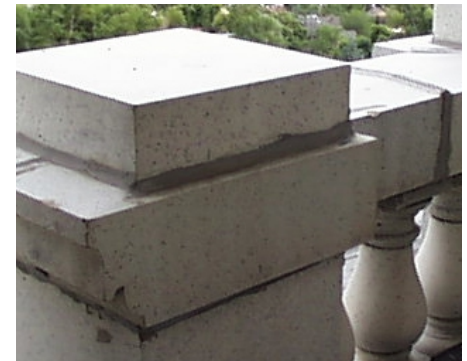
Location: North Elevation

Description: Balustrade

Condition: J

Mortar joint with missing or loose mortar

Comments: newel post at rail

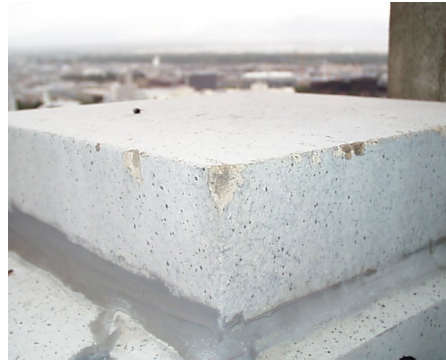
Location: South Elevation

Description: Balustrade

Condition: BR

Broken, severely cracked or
chipped

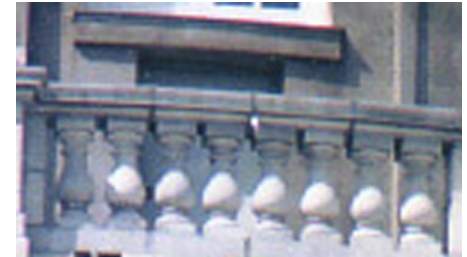
Location: South Elevation

Description: Balustrade

Condition: J

Mortar joint with missing or loose
mortar

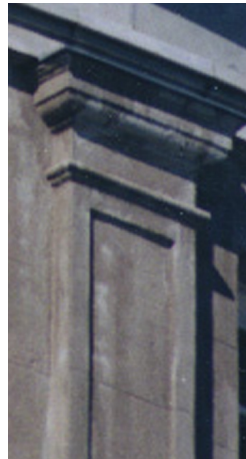
Location: West Elevation

Description: Pilaster shaft

Condition: BR, M, NO

Broken, missing, or non-original
elements

Comments: coursing visible, stucco badly
stained

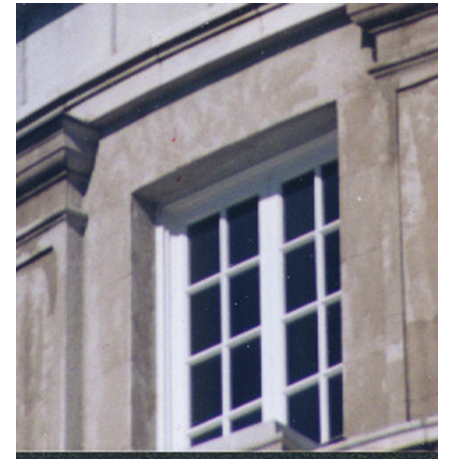
Description: Window trim

Condition: CK

Caulking missing, damaged or
non-matching

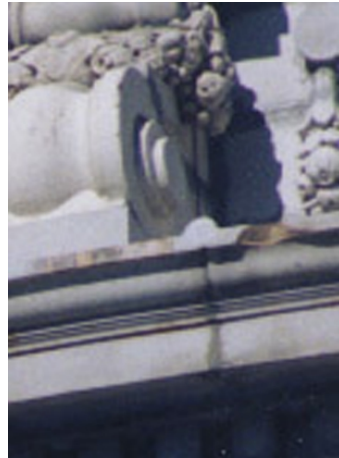
Location: East Elevation

Description: Entablature

Condition: BR

Broken, severely cracked or
chipped

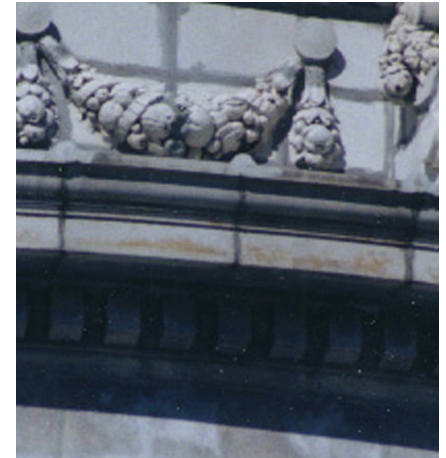
Location: North Elevation

Description: Entablature

Condition: BR

Broken, severely cracked or
chipped

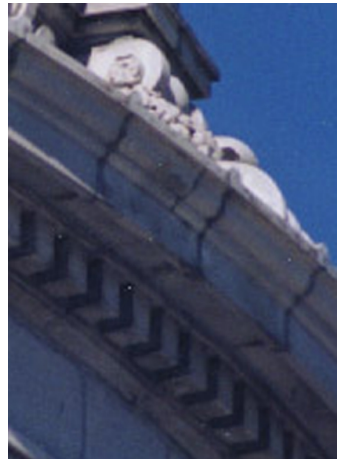
Location: East Elevation

Description: Cornice

Condition: BR

Broken, severely cracked or
chipped

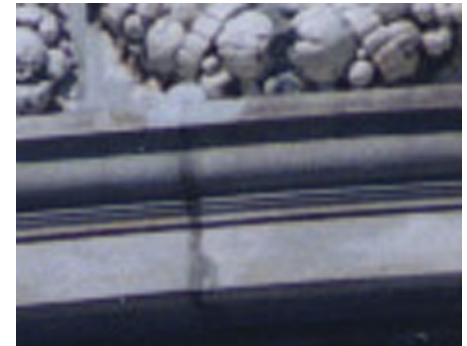
Location: North Elevation

Description: Cornice

Condition: CR

Cracked element

Comments: repaired but not in good condition.

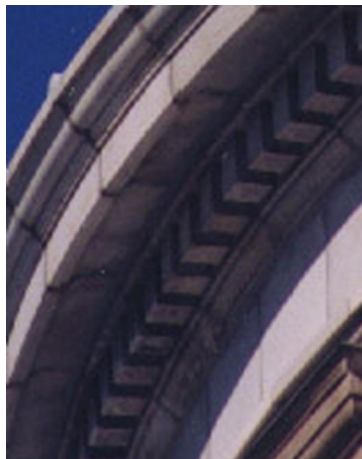
Location: North Elevation joint underneath

Description: Cornice

Condition: ST

Significant Staining; may
indicate rusted connector

Comments: white and brown rust/efflorescence

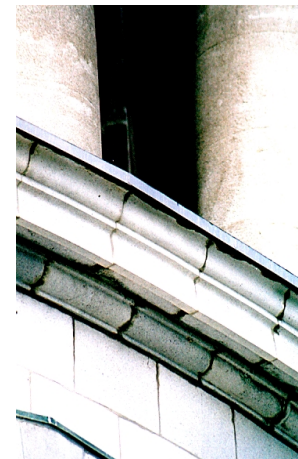
Location: South Elevation

Description: Cornice

Condition: ST

Significant Staining; may
indicate rusted connector
